TECHNICAL REPORT SL-83-6

# AN EVALUATION OF THE SEPARATED BAY CONCEPT FOR A MUNITION ASSEMBLY COMPLEX; AN EXPERIMENTAL INVESTIGATION OF THE DEPARTMENT OF ENERGY BUILDING 12-64 COMPLEX

Structures Laboratory

Prepared for Department of Energy, Albuquerque Operations  
Amarillo Area Office, Amarillo, Texas 79120

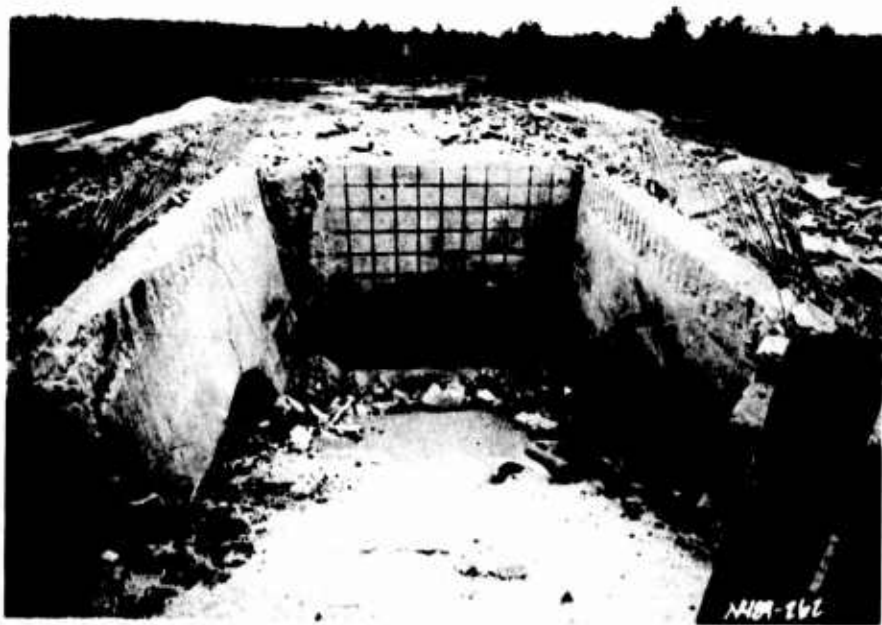
An overall view of the donor bay immediately after the test is shown in Figure 4.2. The roof disengaged and completely separated from the bay leaving only a few No. 5 bars which had pulled out of the roof slab. The roof slab broke into two major fragments which impacted to the east and west of the donor bay. The north wall completely separated from the floor and the east and west walls and fell back onto the bay floor. The east wall was displaced and rotated away from the center of the bay, and the corrugated entrance pipe was destroyed. The south and west walls suffered much less severe damage. Post-test donor bay relative displacements were measured between the east and west walls and are listed in Table 4.3.

Figure 4.2. Posttest view of donor bay.

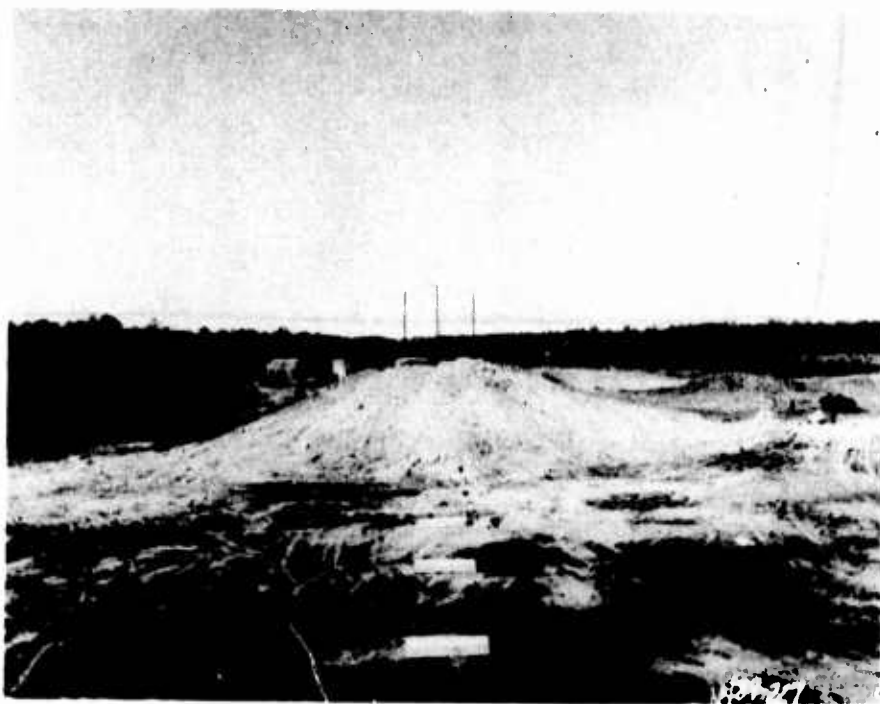
The roof slab broke into two major fragments, approximately 9 by 31 ft in plan, which impacted 104 ft to the east and 102 ft to the west of the bay (Figure 4.3). Analysis of high-speed photography from camera station 1 revealed that the major roof fragment on the west side of the bay achieved a terminal velocity of 52 fps. The two major roof slab fragments are shown in Figures 4.4 and 4.5. The concrete covering the rebar splices at the east and west edges was spalled away from the bars. These secondary fragments were primarily distributed on the east and west backfill slopes, as shown in Figure 4.6.

Figure 4.3. Posttest view of Phase I test site.

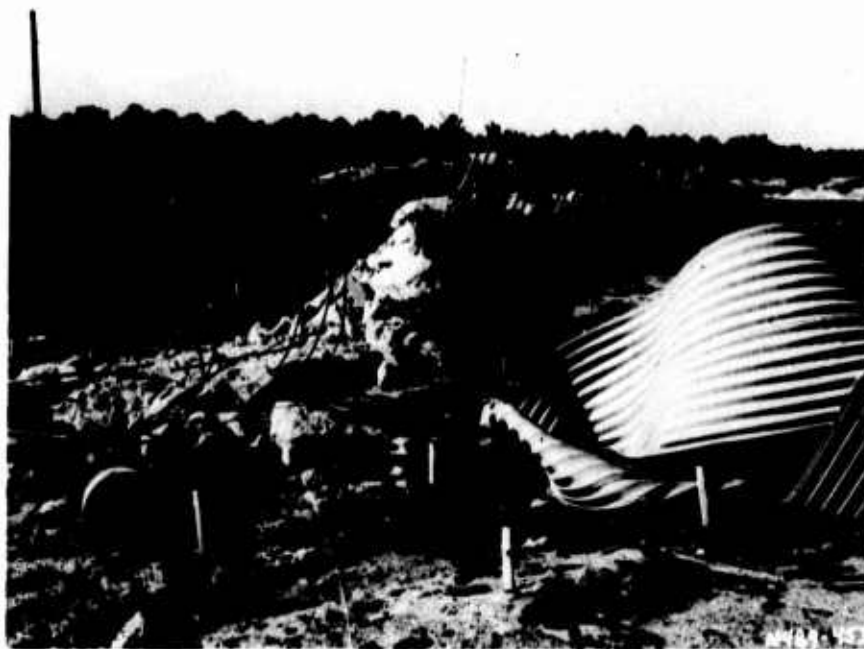
a. View facing east.

b. View facing northwest.

Figure 4.4. Major roof-slab fragment on east side of structure.

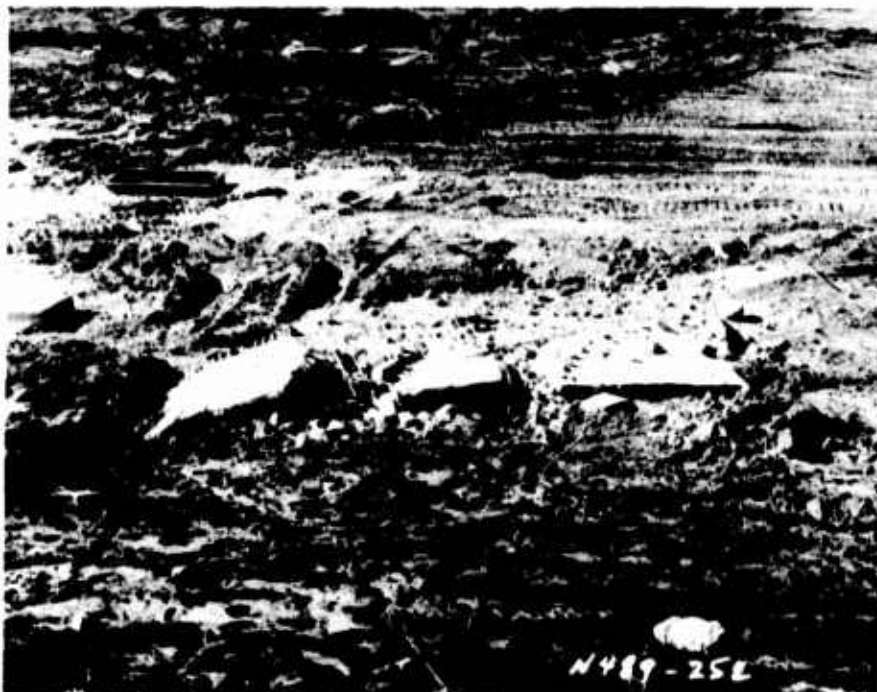
a. View facing west.

b. View facing north.

Figure 4.5. Major roof-slab fragment on west side of structure.

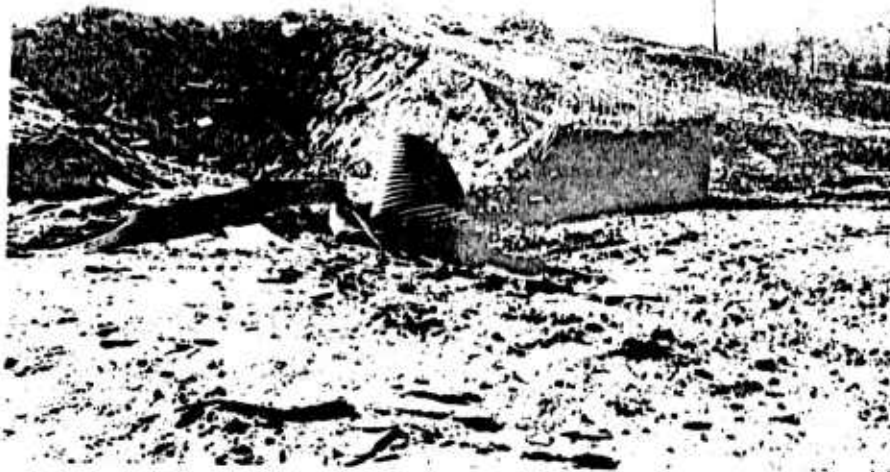
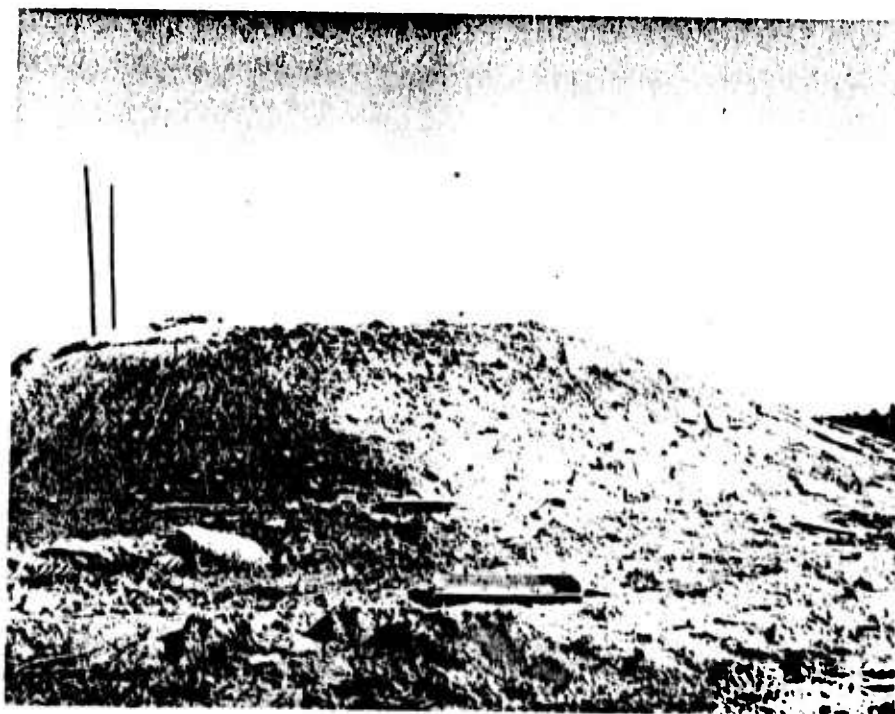
a. East slope.

b. West slope.

Figure 4.6. Posttest view of backfill slopes on Phase I structure.

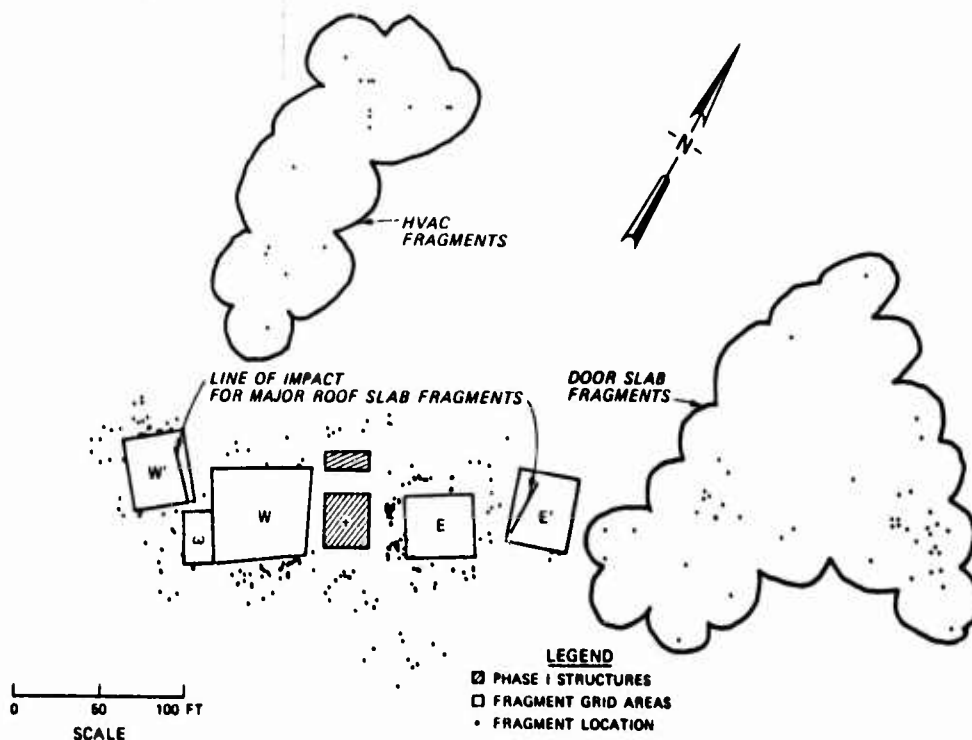
Individual fragment locations and fragment grid areas are shown relative to the Phase I structures in Figure 4.7. The figure shows the locations of all fragments which impacted outside of the five grids (E, E', W, w, and W'). The fragment content within these areas was too dense to produce a legible map. Grids E, W, and w represent the east and west backfill slopes. Grids E' and W' were impact areas for the two major roof slab fragments.

Figure 4.7. Individual fragments and grid areas relative to Phase I structures.

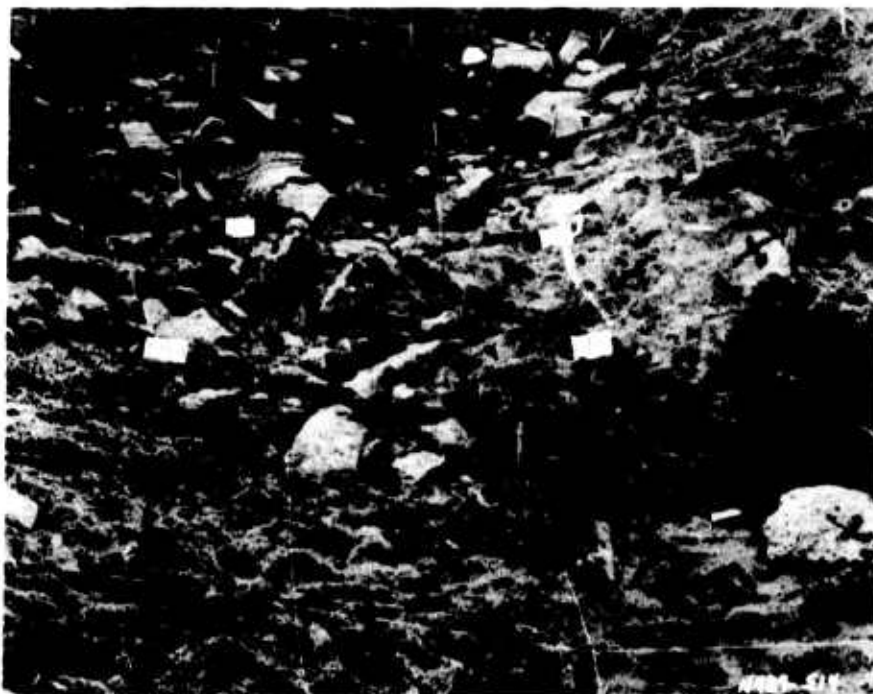
Figure 4.9. East slope with E grid.

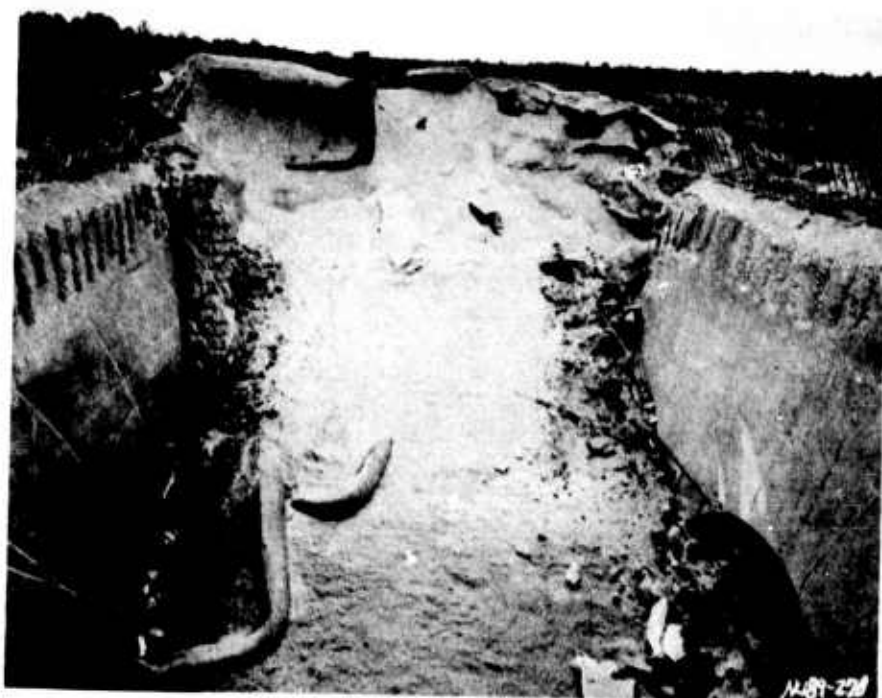
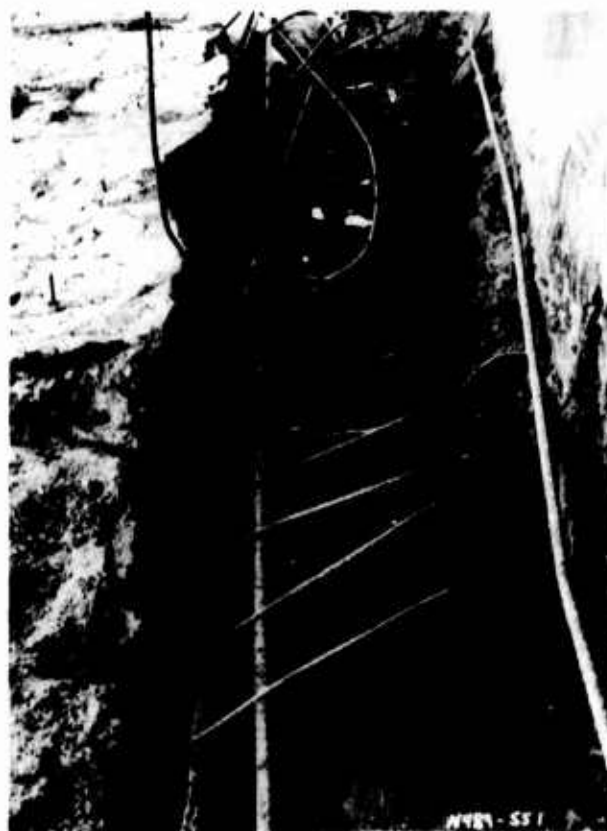
Figure 4.11a shows the north wall shortly after the test event. The wall was excavated to remove the sand backfill which fell back into the bay. Figure 4.11b shows the exterior face of the north wall. The collapse of the wall left all No. 8 dowel bars joining the floor to the wall intact. The wall broke away from the floor slab as shown in Figure 4.11c. The portion of the wall left standing on either side of the center of the wall was 36 in. high and was broken flush with the top of the floor dowels. The wall's inside face vertical No. 8 rebar merely pulled away from the dowels without apparent deformation. Of the outside face vertical No. 4 rebar, 9 bars pulled out and 11 were broken. The center of the wall adjacent to the charge location was crushed and spalled. The distance from the top of the wall to the spalled and crushed area was 14 ft 10 in.

a. Before excavation.

b. North view after excavation.

Figure 4.11. Posttest view of north donor bay wall  
(Sheet 1 of 3).

c. South view after excavation.

d. West edge of wall.

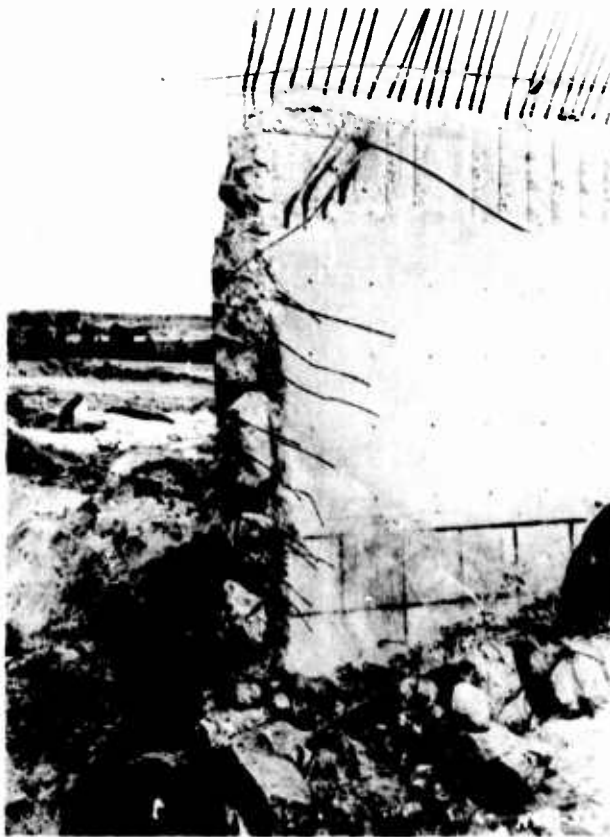
e. Northwest corner.

On the northwest edge, the wall opened up at the corner but it broke away approximately 2 ft from the edge leaving a section of the wall attached to the west wall (Figure 4.11e). At the separation point, all of the inside face steel rebars spalled their concrete cover and pulled away. All of the No. 4 rebars in the outer face horizontal direction failed in tension. Four No. 4

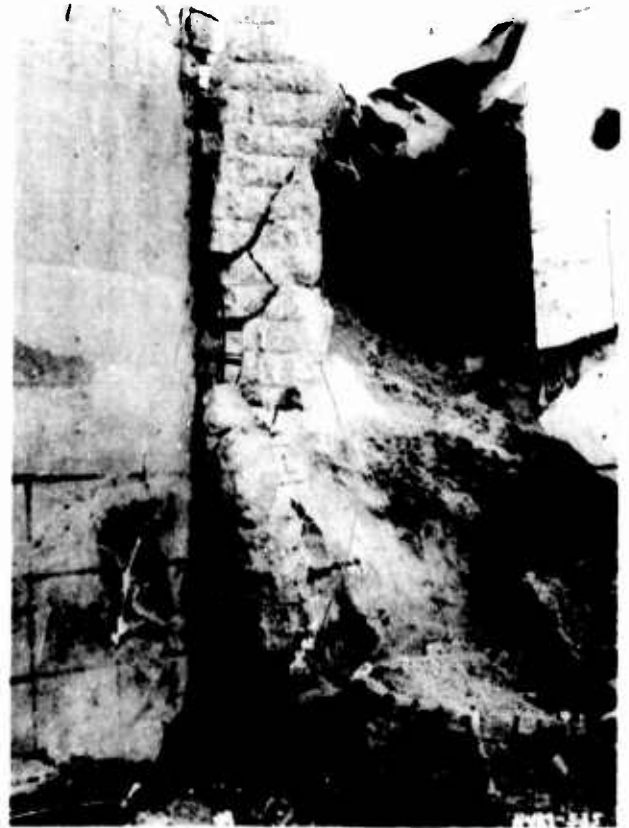
f. Northeast corner.

The northeast edge of the north wall separated from the east wall at the corner as shown in Figure 4.11f. One No. 4 vertical rebar from the outside face mat was left embedded at the east wall. The outside face No. 4 horizontal rebar pulled out at the corner with minimal damage while all of the inside face No. 4 horizontal bars were broken. The corner reinforcement details included No. 5 horizontal steel from the east wall bent 90 deg around the corners into the north wall (see Figure 2.13). On the outside face, 3 No. 5 bars were broken and 13 pulled out of the north wall. On the inside face 4 No. 5's were broken and 10 pulled out.

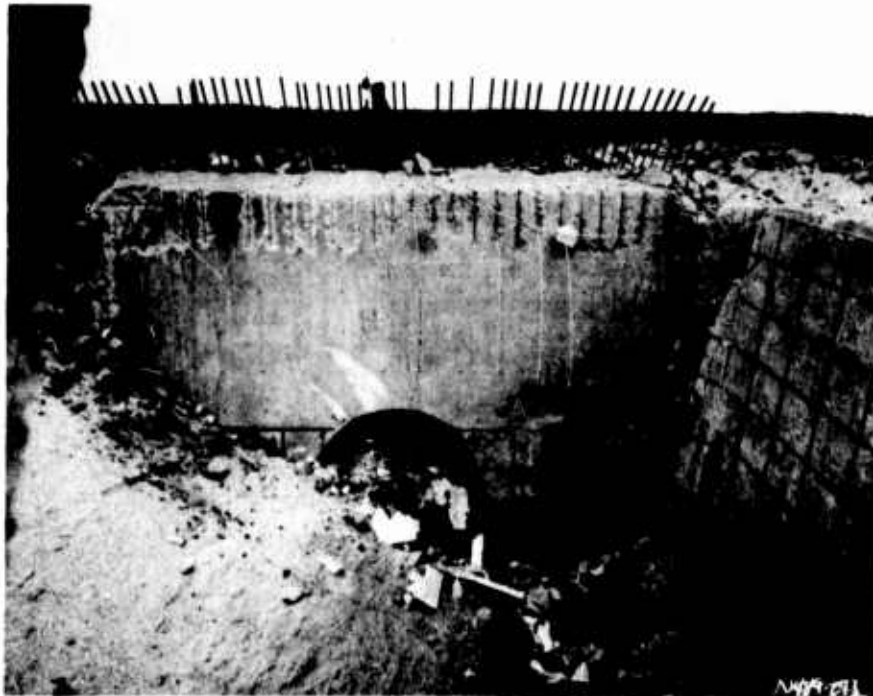
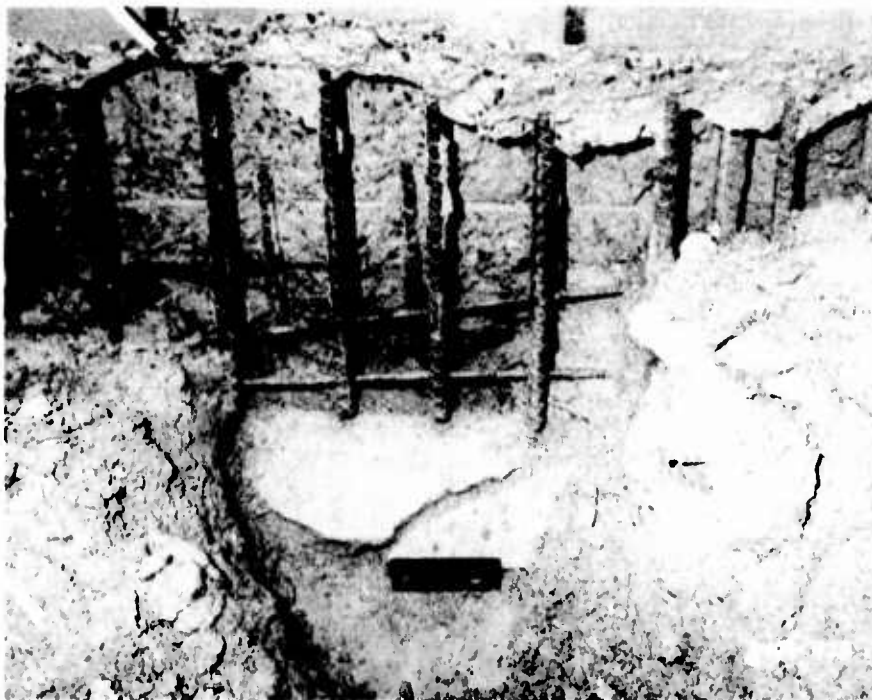
A pictorial view of the east wall is shown in Figure 4.12. Damage to the wall is identified in Figure 4.13. The top of the wall was rotated away from the center of the bay producing posttest angular displacements ranging from 5.4 deg at the north side to 11.1 deg at the base of the south side. This rotation is evident in Figure 4.12a and caused the inner face reinforcing steel mat to separate from the floor dowels as shown in Figure 4.12b. The inward displacement of the No. 9 vertical rebar was 8.75 in. where the photograph in the figure was taken. The concrete covering these bars was separated from the wall to an elevation of approximately 8.5 ft from the floor. One major vertical crack ran from near the crest of the entrance pipe to the top of the wall.

a. Overall view.

b. Reinforcement separation at base of wall.

Figure 4.12. Posttest view of east donor bay wall.

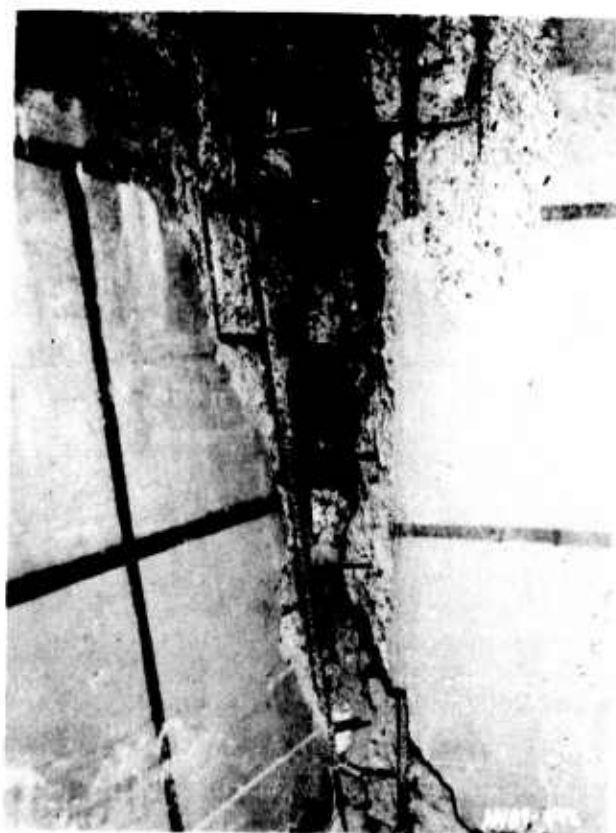
The posttest condition of the south wall is shown in Figure 4.14 and damage is detailed in Figure 4.15. The wall suffered significant damage at the edges, but the remainder of the wall remained in relatively good condition. Other than the edges, cracking was limited to one vertical hairline crack near

d. Lower interior view of southeast corner.

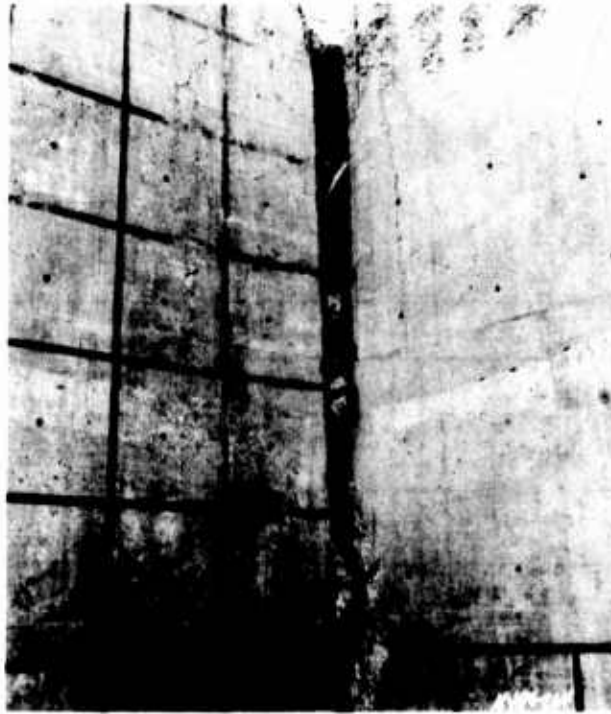
e. Interior view of southwest corner.

Damage to the south and west walls of the Phase I donor bay is very similar to the damage to the Phase II south and east bay walls. South wall damage can be compared using Figures 4.14 and 4.15 for Phase I and Figures 5.10 and 5.11 for Phase II. The formation of hinge mechanisms and cracking at the corners are very similar. The southeast corner of the Phase I wall was more heavily damaged in the Phase I bay due to large rotation of the east wall. The posttest condition of the west Phase I wall and the east Phase II wall can be compared using Figures 4.16 and 4.17 versus Figures 5.8 and 5.9. The crack and damage patterns are similar.

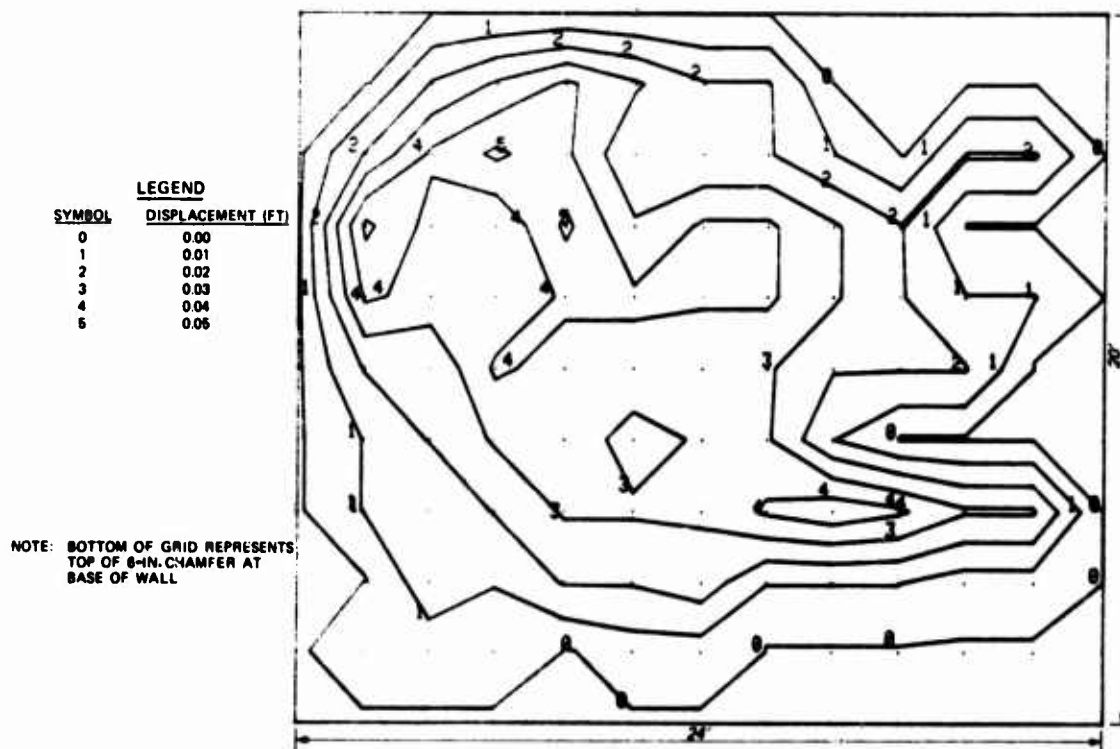
Figure 4.21. Acceptor bay wall posttest displacement contours.

The crack pattern and posttest deflections show that the acceptor bay wall responded in a flexural mode. This is consistent with the load distribution measured on the face of the wall. There was no indication of a punching shear failure.

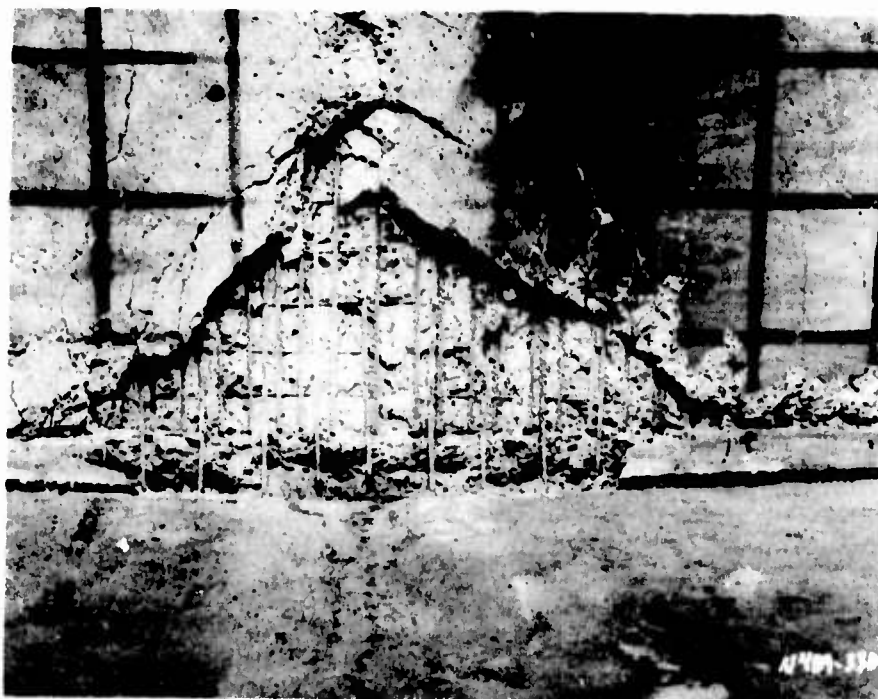
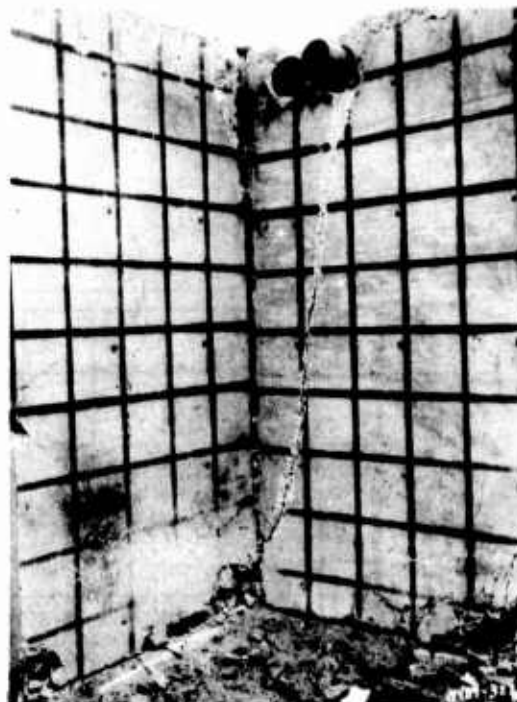
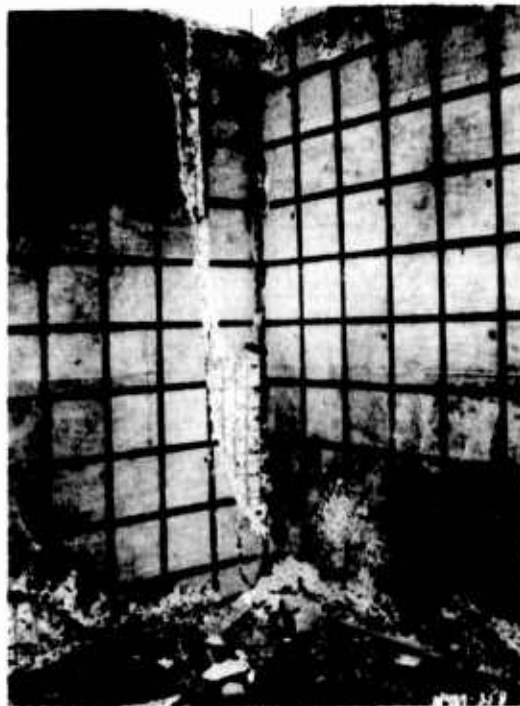
Figure 5.6. Posttest view of north donor bay wall  
(Sheet 1 of 2).

The posttest condition of the north wall is shown in Figure 5.6. The damage was mapped and the map is presented in Figure 5.7. The area adjacent to the explosive charge was badly cracked and spalled leaving a significant portion of the innerface reinforcing steel mat exposed. One vertical crack near the center extended to the top of the wall.

b. Damage adjacent to explosive charge.

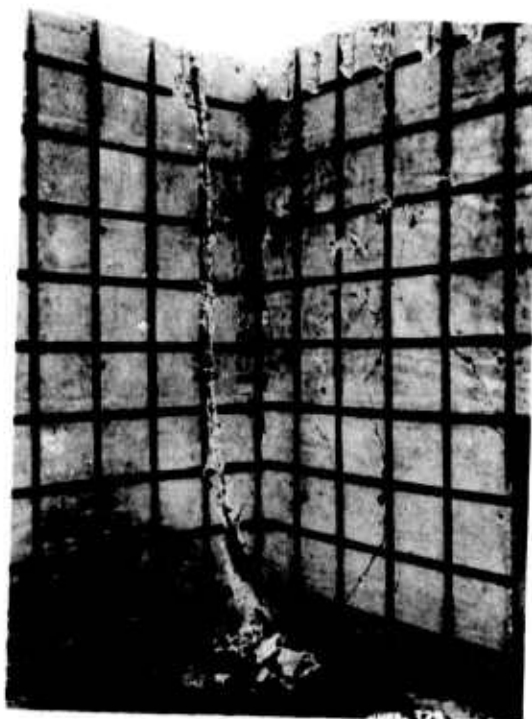
d. Southwest corner.

Damage to the south wall was very similar to that of the north wall except there was no local spalling at the center since the charge was detonated near the north wall. The wall is shown in Figure 5.10, and posttest damage is shown in Figure 5.11. Although the corners were seriously damaged, the damage to the remainder of the wall was limited to spalling at the base of the wall and two small vertical cracks which terminated 4 ft from the floor.

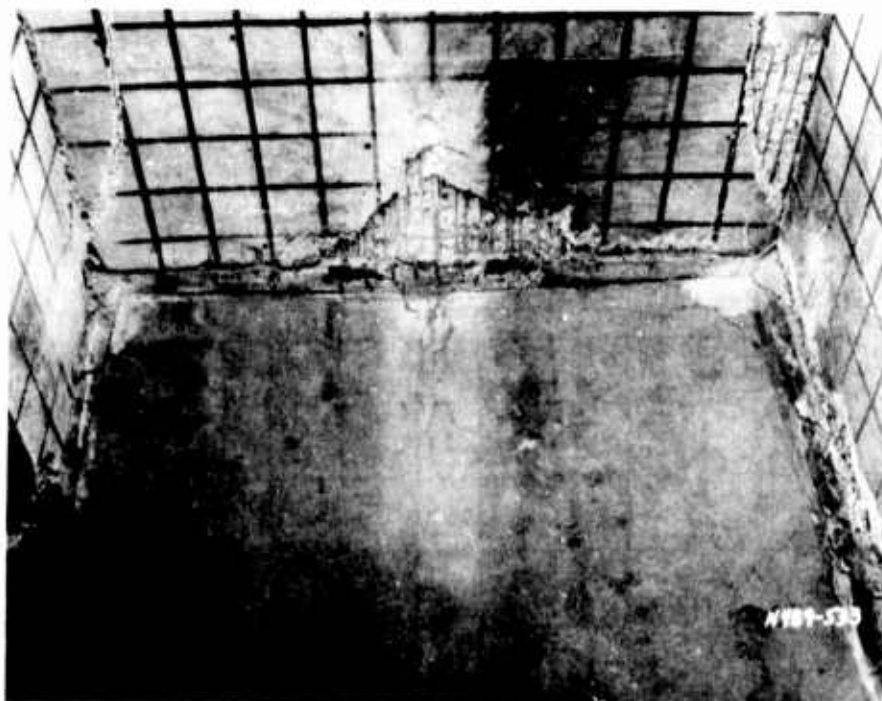
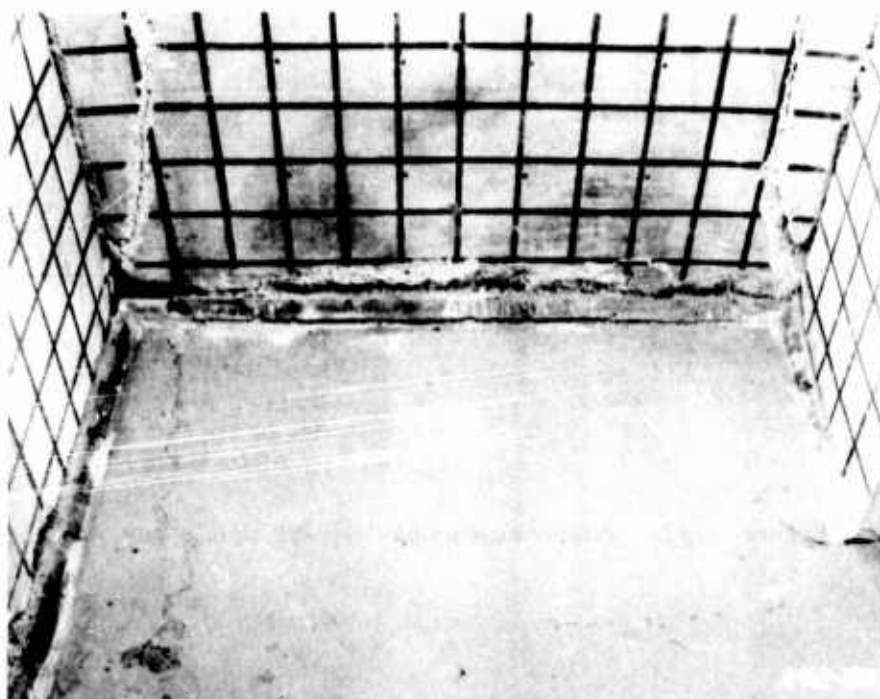
Figure 5.14. Posttest view of donor bay floor after removal of debris.

Damage to the floor slab included hairline cracks near the location of the explosive charge and cracks adjacent to the east and west walls. Spalling was limited to an area near the northwest corner of the slab. A pictorial view of the slab is shown in Figure 5.14 and the damage is mapped in Figure 5.15.

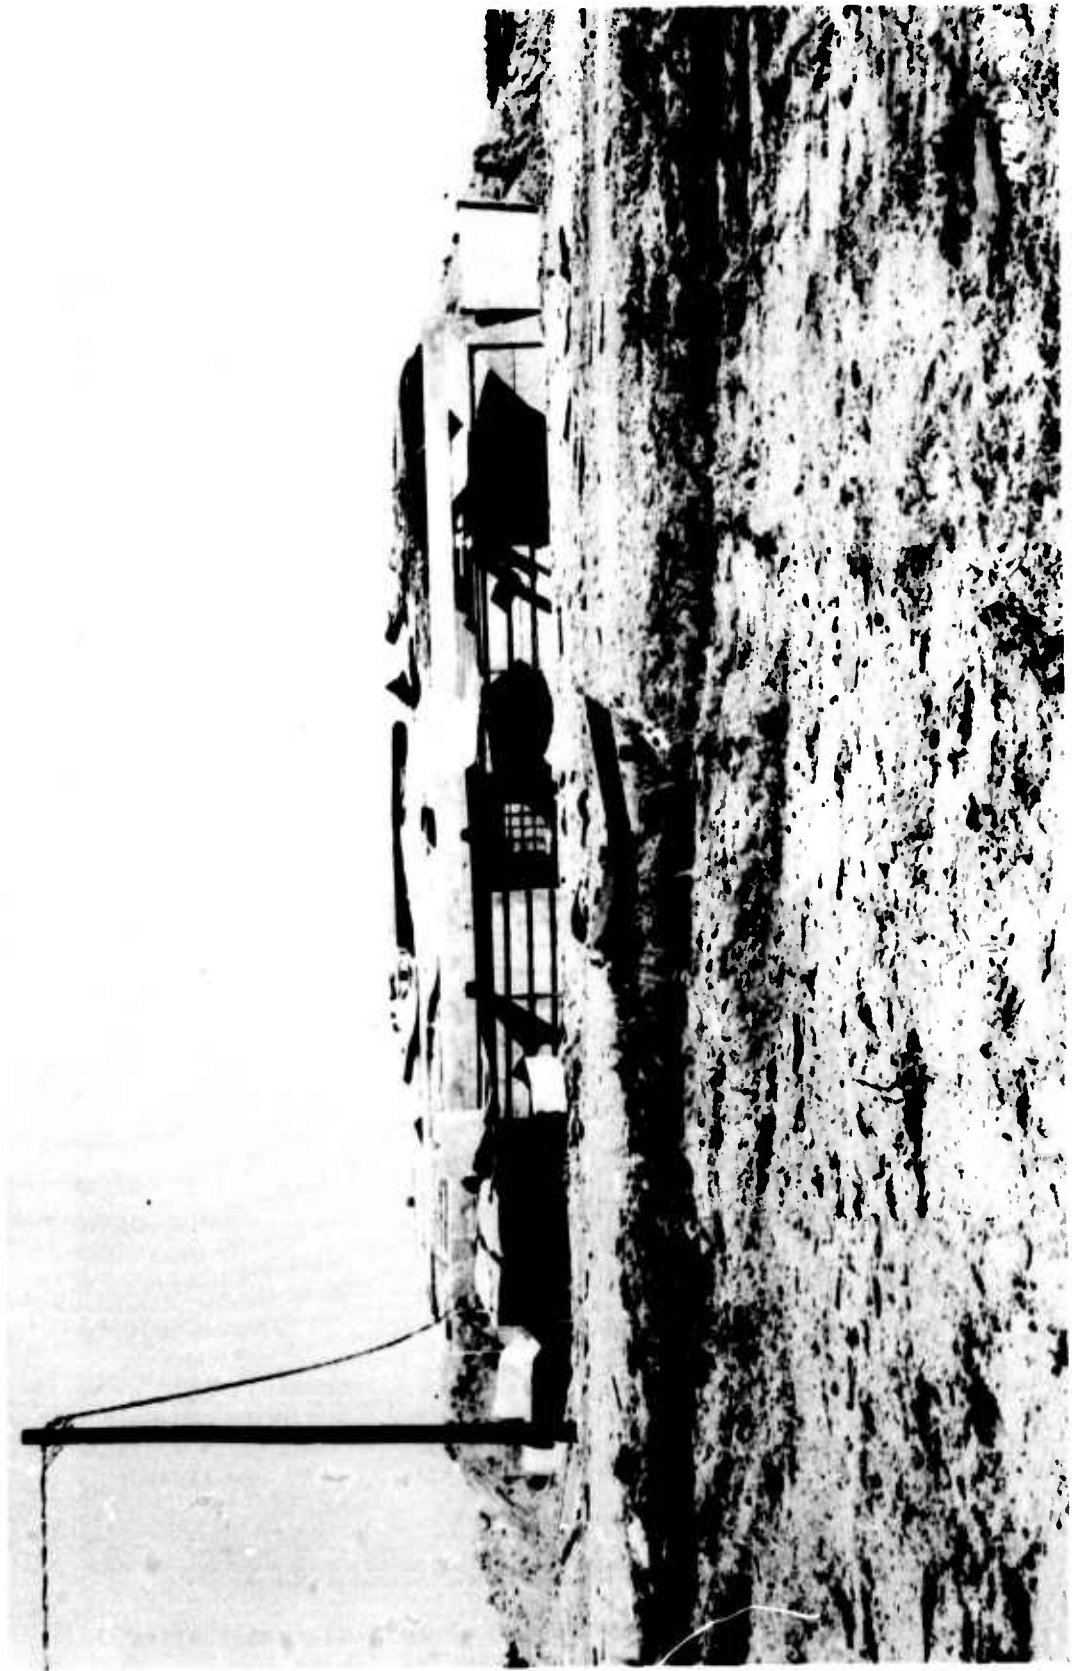
Figure 5.20. Posttest view of Phase II structure.

An overall posttest view of the ramp and Phase II structure is shown in Figure 5.20. All of the cimento board on the walls and virtually all of it on the roof were destroyed during the test. All aluminum roofing material was removed. The aluminum sheets seen on the ramp in Figure 5.20 fell back to that position after the test. Figure 5.21 shows a more detailed view of the ramp damage. All of the self-tapping screws remained in place as the cimento board fractured around them. The column in front of the donor bay was struck by debris from the air lock and broke away from the roof beam. It came to rest 417 ft east of the ramp. The girt attached to the column also broke away from the ramp and impacted several feet from the ramp. The impact load transmitted to the ramp also caused the beam and column immediately north of the donor bay air lock to break away from the retaining wall and to shear column baseplate bolts. The displacement of this member can be seen in Figure 5.21.

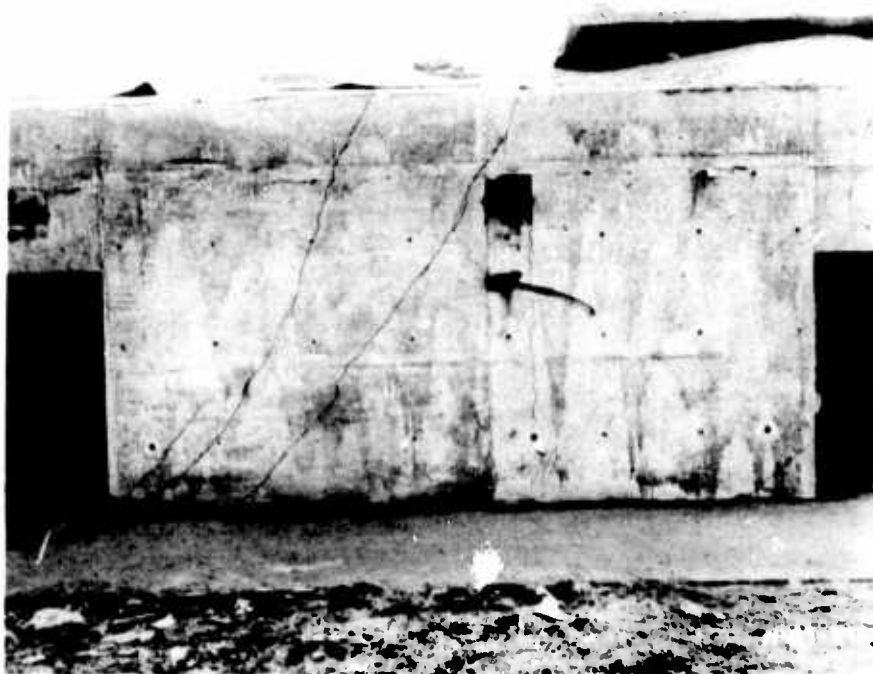
a. North of donor air lock.

The retaining wall experienced minor cracking. Figure 5.22 shows a post-test view of the wall after the ramp structure and debris were removed. More detailed views of the crack patterns are given in Figure 5.23. All cracks in the photographs were less than 0.1 in. wide and were enhanced with felt-tip pens for the photographs.

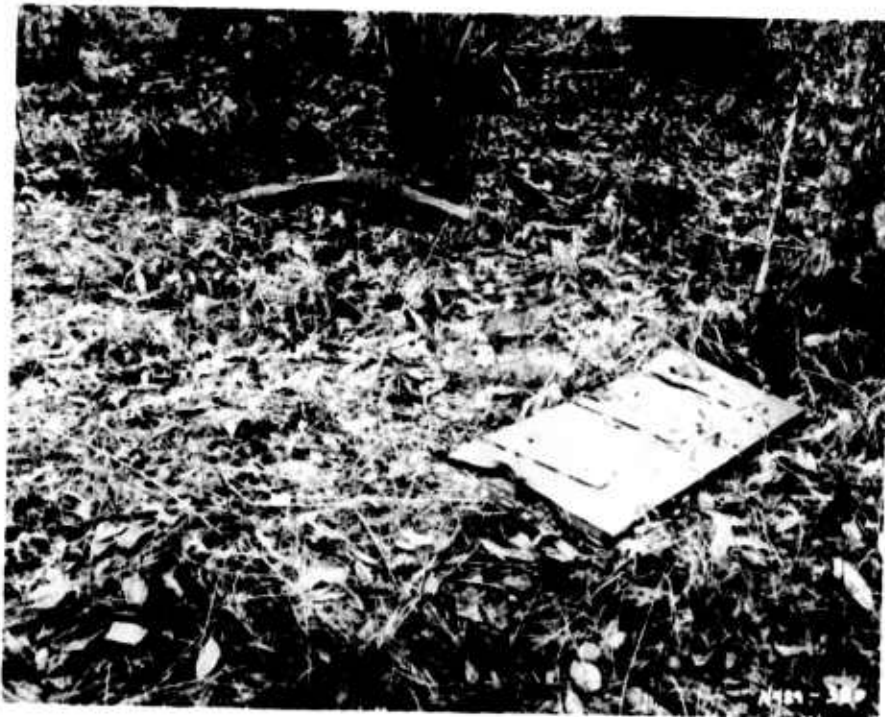
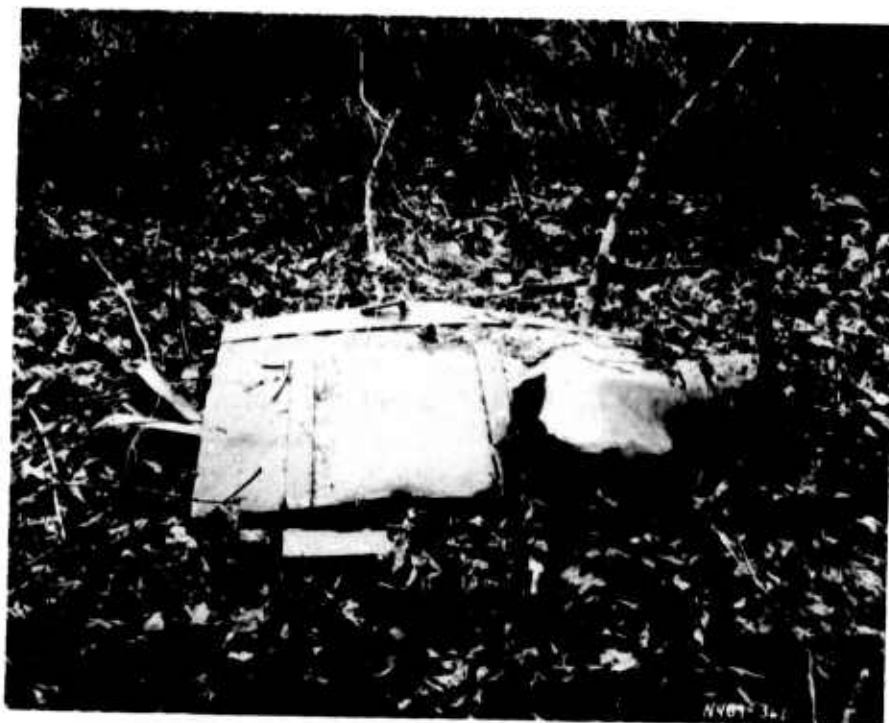
Figure 5.28. Posttest view of donor bay blast doors.

The bulkhead, doorframe, and blast doors were completely removed from the air lock. The entire assembly became five separate fragments: the upper portion of the bulkhead (Figure 5.25); the south part of the bulkhead (Figure 5.26); the north part of the bulkhead with the doorframe (Figure 5.27); and the inactive blast door leaf and the active blast door leaf (Figure 5.28).

The blast doors broke away from the doorframe after breaking their hinge straps at the hinge pins. The lower locking bolt in the inactive (locked) leaf did not fail, but it rotated within the door and elongated the bolt holes in both the door and the embedded floor plate. The upper locking bolt was found undamaged and in the fully extended position. The interior skin plate on the inactive leaf was badly buckled and the entire door was severely damaged. The interior skin on the active leaf was also buckled, but the only other damage to the door was dents at the upper and lower edges. The active and inactive leafs came to rest 412.5 and 507.6 ft, respectively, from their initial position. The column broken from the ramp was found next to the active leaf as shown in Figure 5.28a.
